REPORT TITLE SURFACE CHEMICAL METHODS OF DISPLACING WATER AND/OR OILS AND SALVAGING FLOODED EQUIPMENT: PART 6 - FIELD EXPERIENCE IN REMOVING SEAWATER SALT RESIDUES FROM AIRCRAFT COCKPITS AND AVIONICS EQUIPMENT

H.R. Baker, R.N. Bolster, and P.B. Leach

December 12, 1968	74. TOTAL NO. OF PAGES	76. NO. OF REFS
NRL Problem C02-12 b. PROJECT NO. RR 001-01-43-4752	NRL Report 6809	
с. d.	9b. OTHER REPORT NO(5) (Any this report)	other numbers that may be assigned

Part 6 - Field Experience in Removing Seawater Salt Residues from Aircraft Cockpits and Avionics Equipment

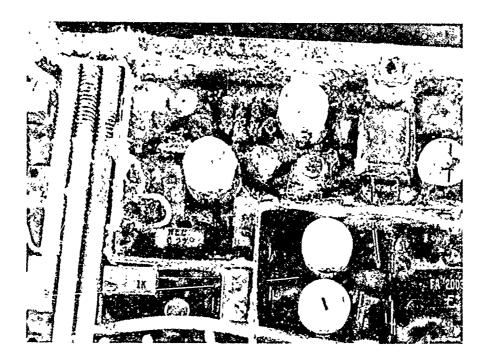
Fig. 4 - Electronic unit, showing salt residue and corrosion products before cleaning. (Photographs courtesy of Naval Air Rework Facility, Jacksonville, Florida.)

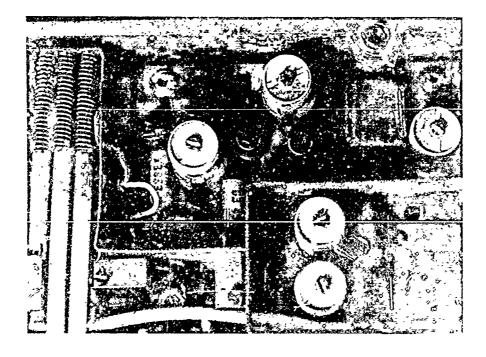
Fig. 5 - Unit shown in Fig. 4, after ultrasonic cleaning

On completion of the cockpit cleaning and rinsing the transducer assemblies were placed in tanks fabricated so that the assemblies covered one end of the tanks below the level of the liquid, and the length was sufficient to accommodate the largest units to be cleaned. One tank was used for cleaning and one for rinsing. The same detergent solution was used for cleaning as was used in the cockpit cleaning. After cleaning and rinsing, the units were sprayed with Spra-Dri (Type II) and placed in an oven at 125°F to dry. The equipment was then bench checked, corroded parts were replaced, and necessary repairs were made. An electronic unit, shown in Fig. 4 contaminated with salt water and badly corroded, is shown in Fig. 5 after having been cleaned ultrasonically for about 5 min, rinsed, and dried.
